Environmental and Runway Surface Conditions During Friction Tests at North Bay Airport: January-February 2002

LM-SMPL-2002-0220
TP 14158E

Nirmal K. Sinha

October 2002

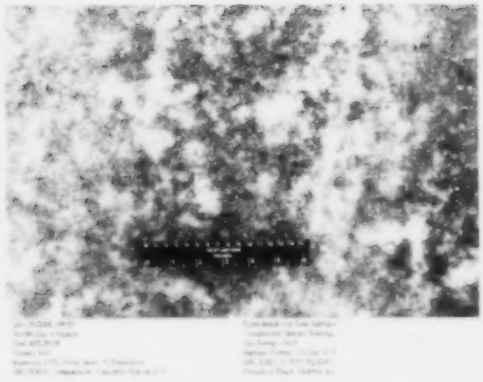
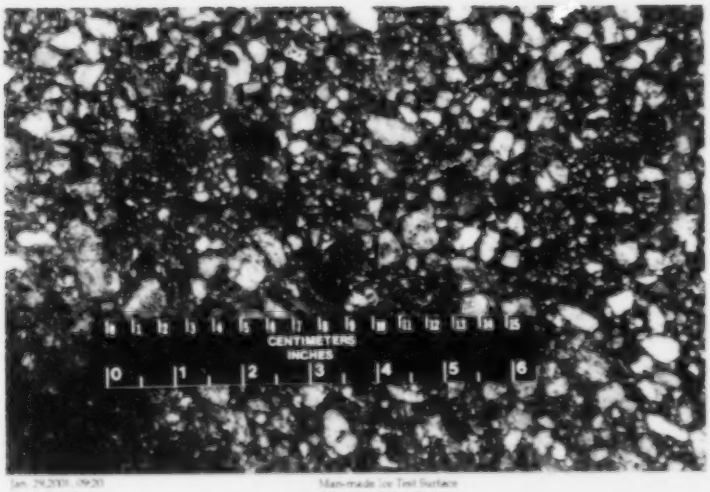
Figure 3. Man-made clear ice strip on the west side of runway 13-31, north of runway 08-26 on the morning of 29 January 2002. Note the white patches of bubbly ice (a) and the details of bubbly ice (b) and clear ice (c)

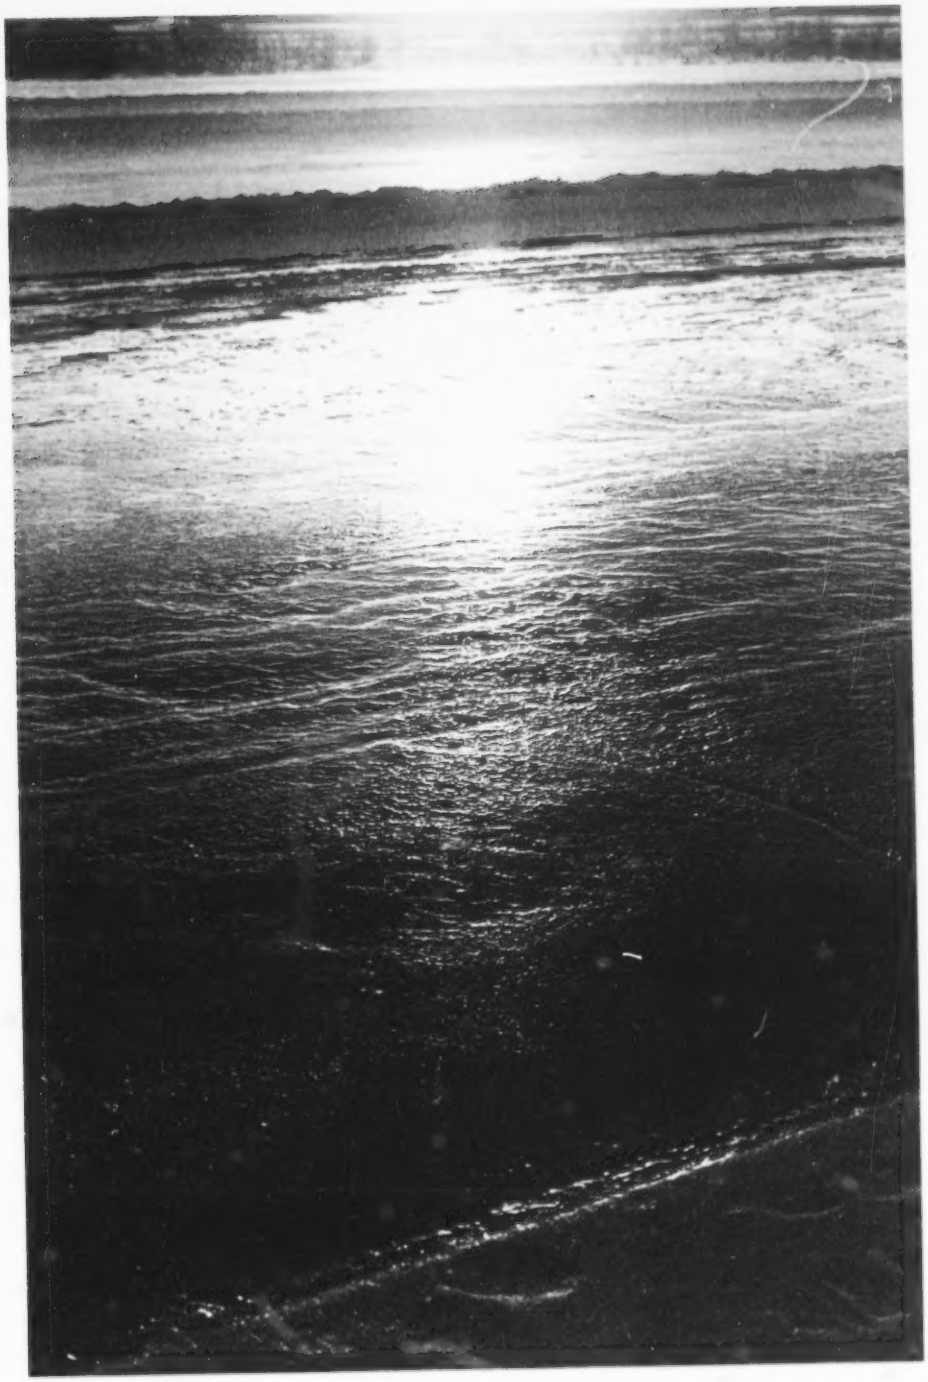
Figure 5a. A general view of the surface texture of the man-made ice strip after all the afternoon ground vehicle tests of 30 January 2002

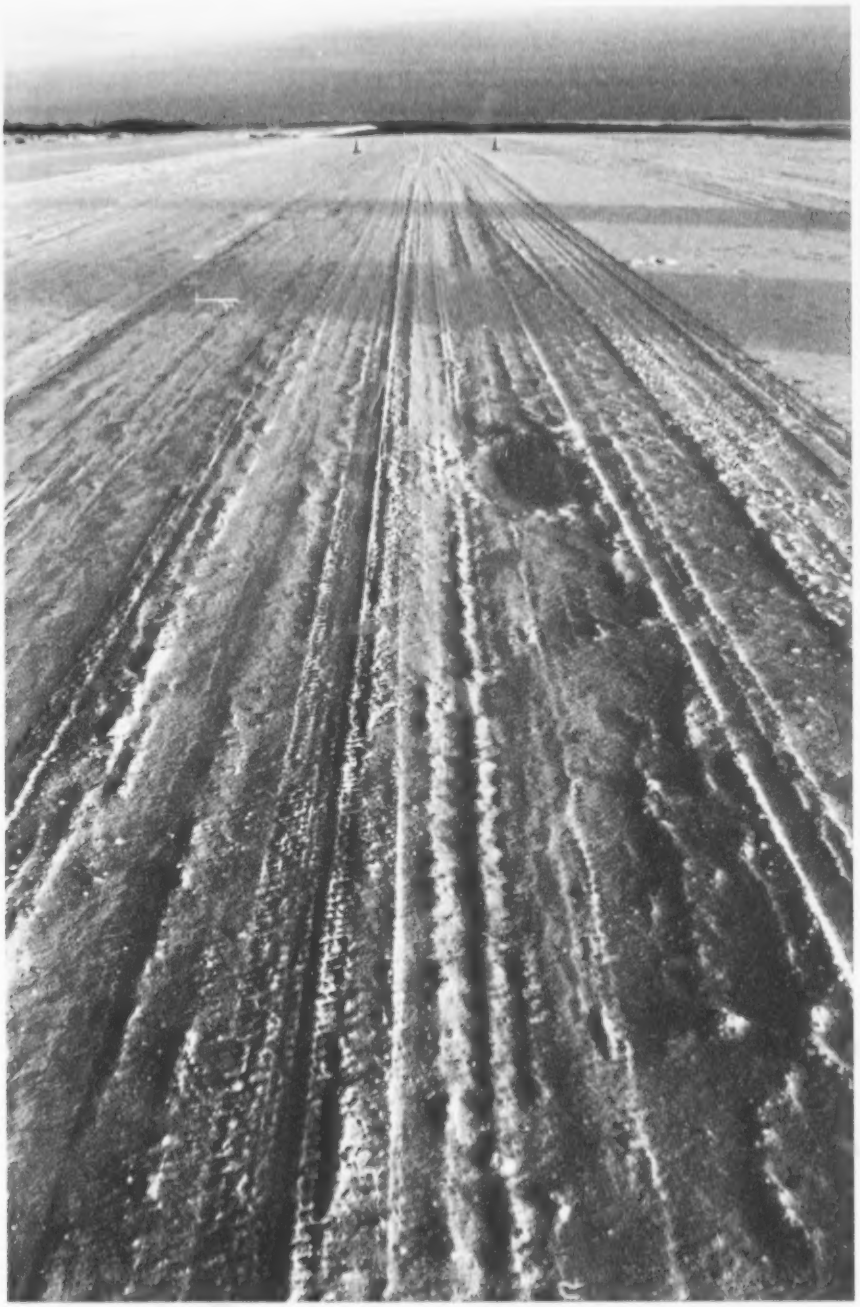
At this stage, the test strip was in a greatly altered (highly damaged) condition, as seen in Figure 5b. It was suggested that the location for next day's tests should be moved a few metres west of this strip.

Figure 5b. A general view of the altered conditions of the compacted snow strip on the east side of runway 13-31 after all the ground vehicle tests of 30 January 2002

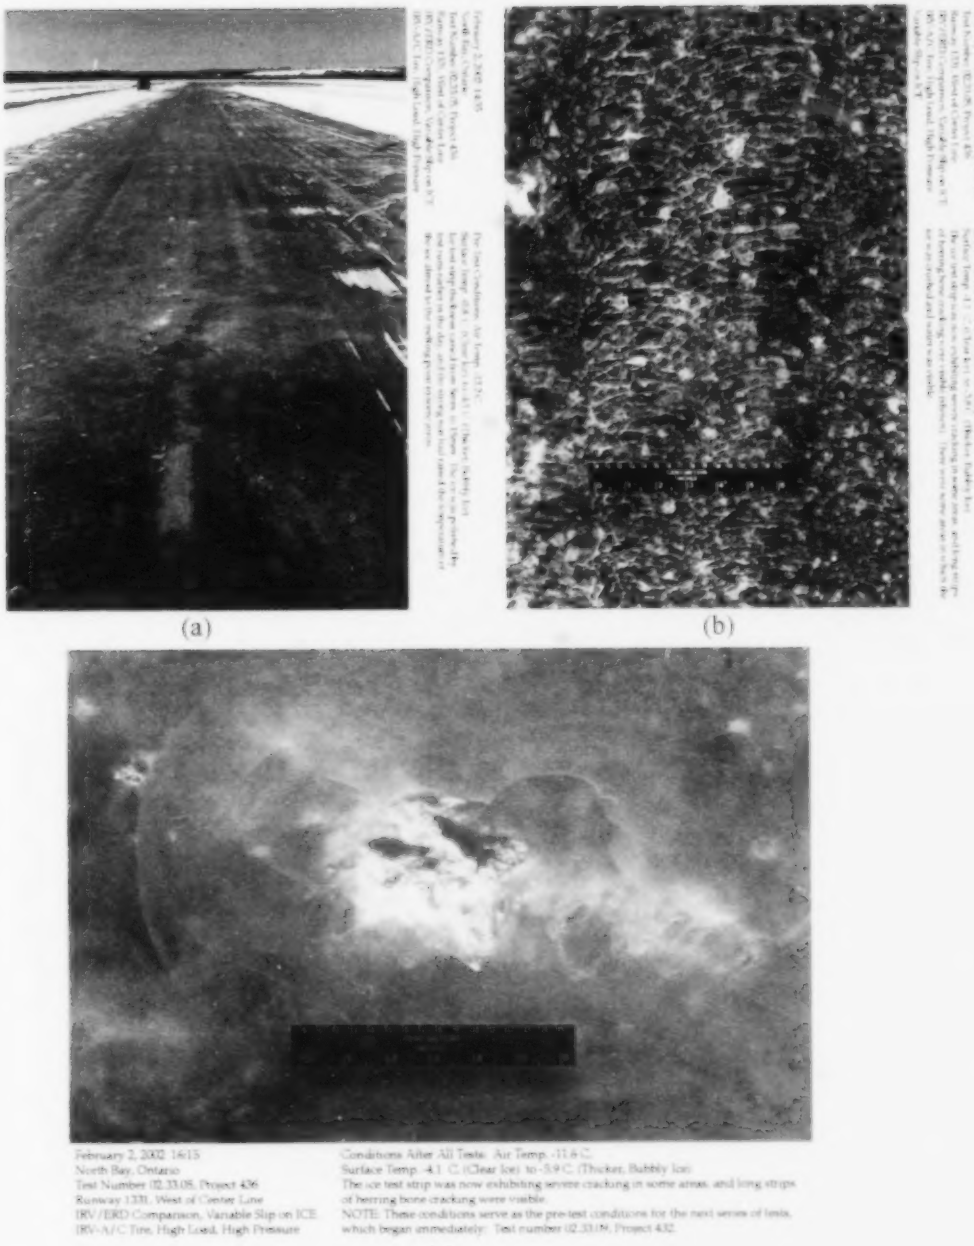
(a) (b)

February 2, 2002 14:35
North Bay, Ontario
Test Number 02.33.05, Project 436
Runway 13/31, West of Center Line
IRV / ERD Comparison, Variable Slip on ICE
IRV-A / C Tire, High Load, High Pressure

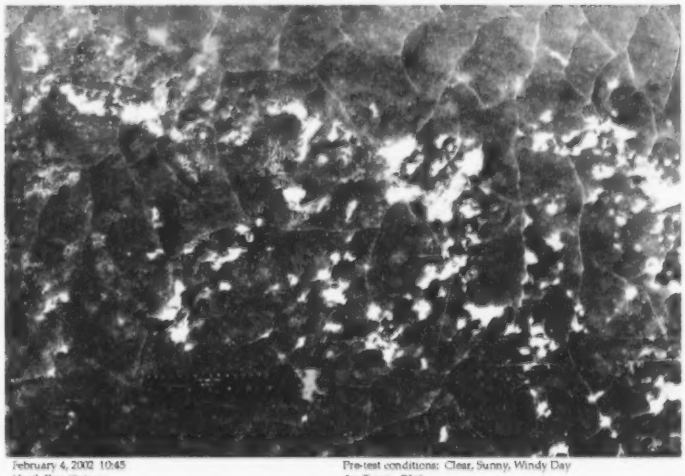
February 4, 2002 10:45
North Bay, Ontario
Test # 02.35.01, Project 101
Runway 13/31, 13 Direction
Ice was cracked throughout test surface
as a result of snow removal that morning.

Figure 9. Thermal cracks induced in the ice strip during the morning of 04 February 2002 due to the quick removal of snow cover from it when the ambient temperature was -21 C: general view (top) and a close up (bottom)

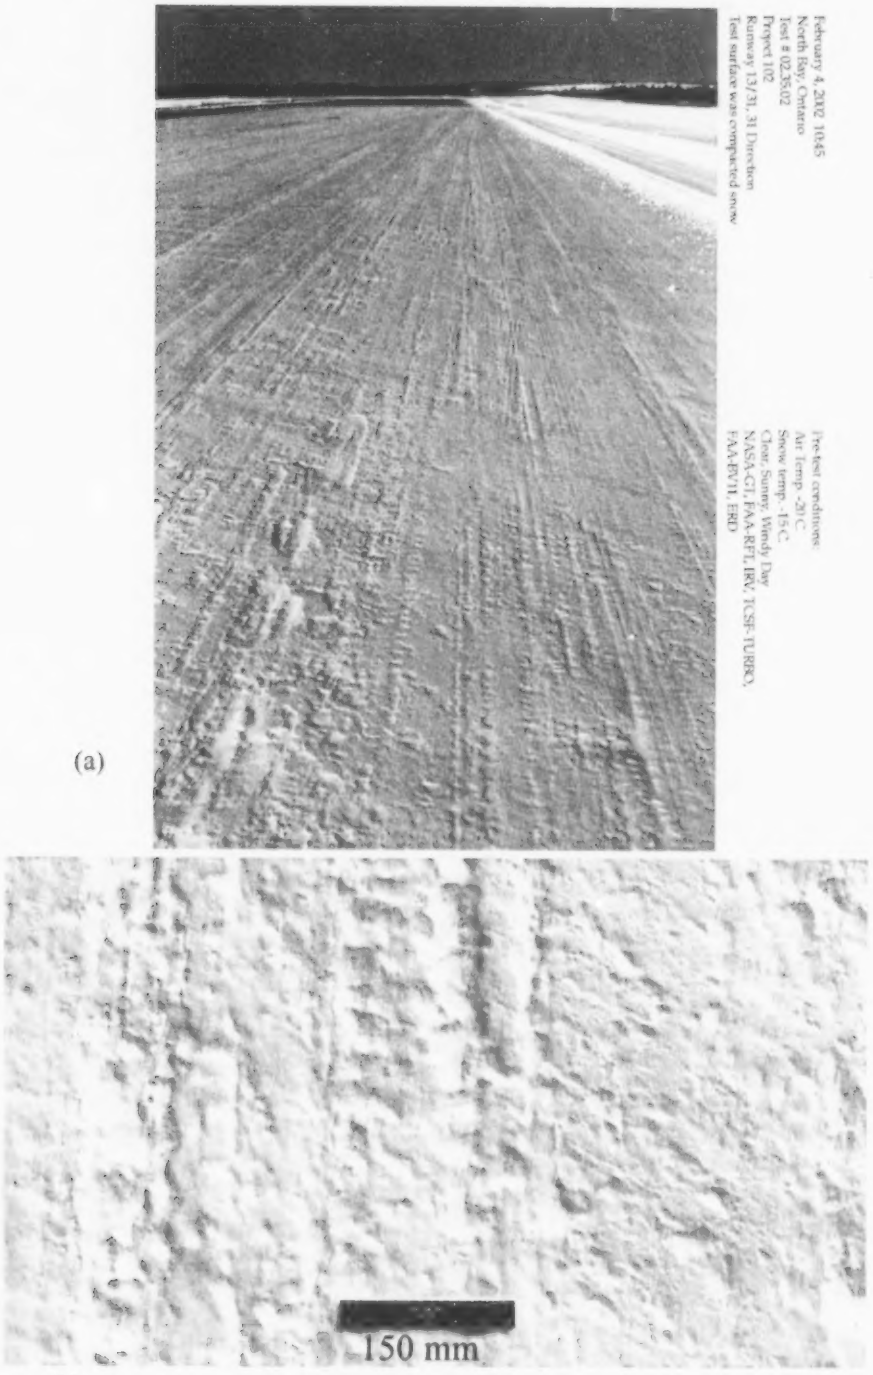
Figure 10. A general view of the compacted snow on the east side of runway 13-31 during the morning tests of 04 February 2002 (a) and a close up of the surface texture (b)

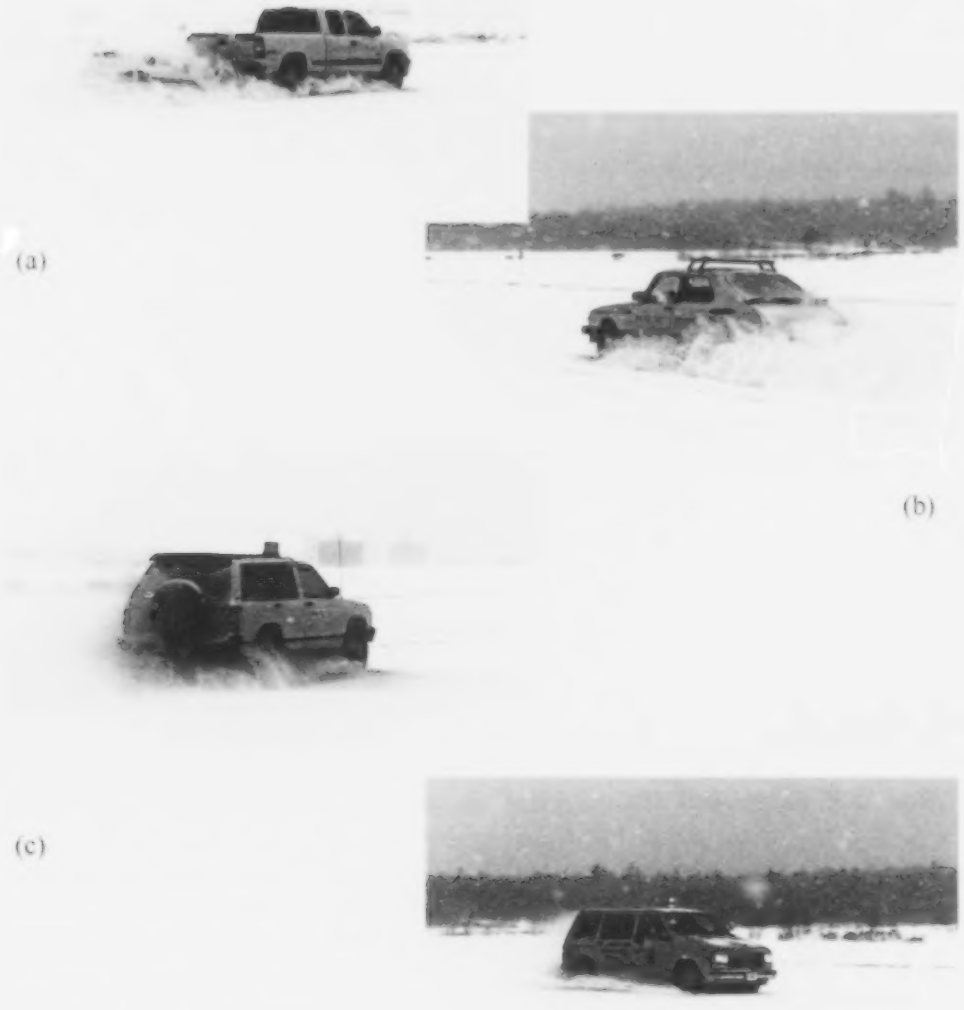
Test No. 02-36-01, Project 301, involving six vehicles – the NASA-GT, FAA-RFT, IRV, TC-SFT-TURBO, FAA-BV11 and ERD – was carried out on runway 18-36, which was covered with freshly fallen snow (Figure 11). The snow was dry and the average depth was 55 mm. One set of runs was made at 65 km/h, on an opportunity basis, on the length of runway from 08-26 to the button of 18. There was a breeze of about 5 km/h from the south, almost parallel to the runway.

Figure 11. 05 February 2002 tests on runway 18-36 covered with 55 mm of fresh snow of density of 34 kg.m^{-3}, showing IRV (a), TC-SFT-TURBO (b), ERD (c) and FAA-RFT (d)

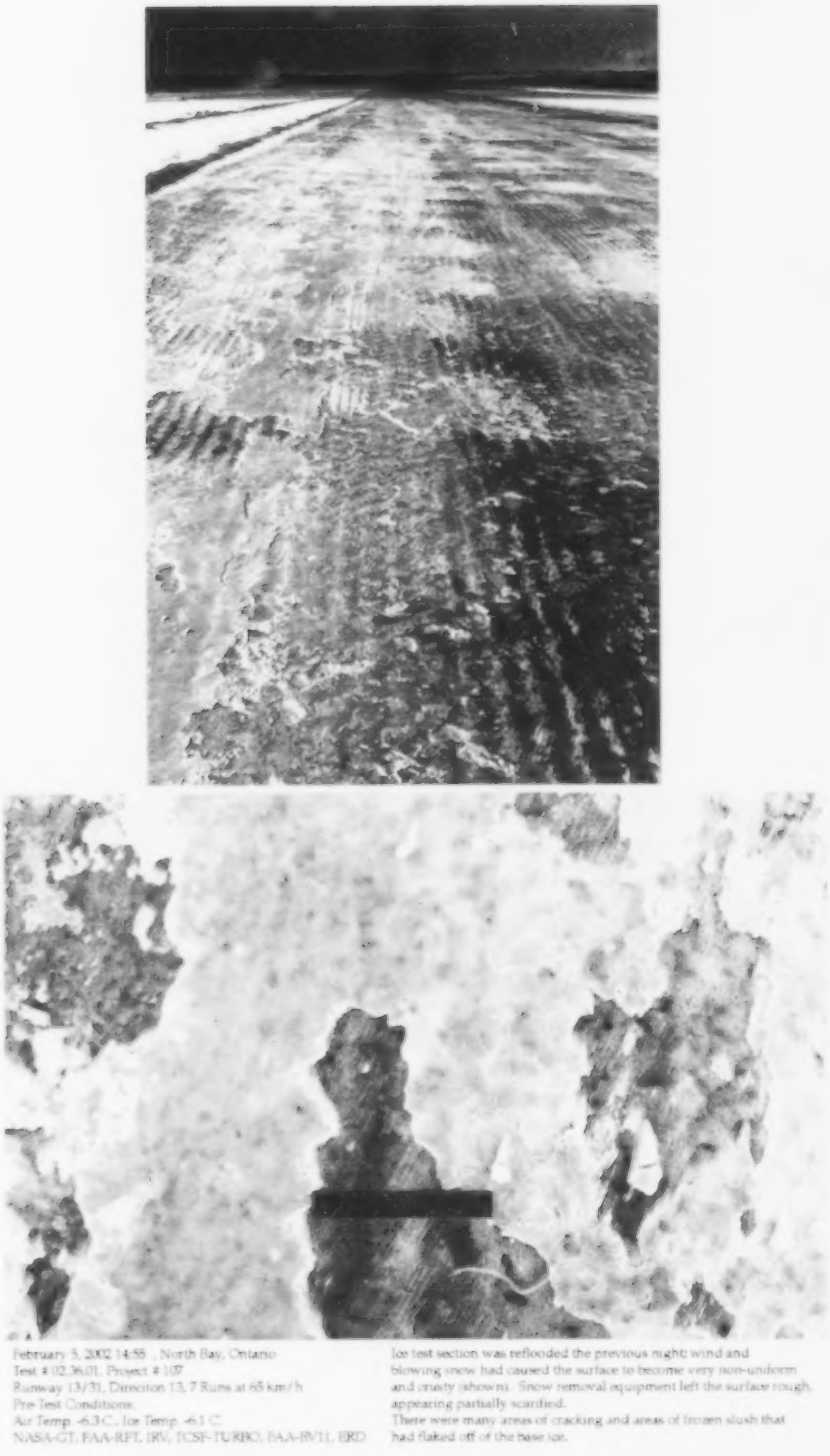
February 5, 2002 14:55 , North Bay, Ontario
Test # 02.36.01, Project # 107
Runway 13/31, Direction 13, 7 Runs at 65 km/h
Pre-Test Conditions:
Air Temp. -6.3 C, Ice Temp. -6.1 C
NASA-GT, FAA-RPT, IRV, TCSF-TURBO, FAA-IRVTL, ERD

Ice test section was reflooded the previous night; wind and blowing snow had caused the surface to become very non-uniform and crusty (shown). Snow removal equipment left the surface rough, appearing partially scarified.
There were many areas of cracking and areas of frozen slush that had flaked off of the base ice.

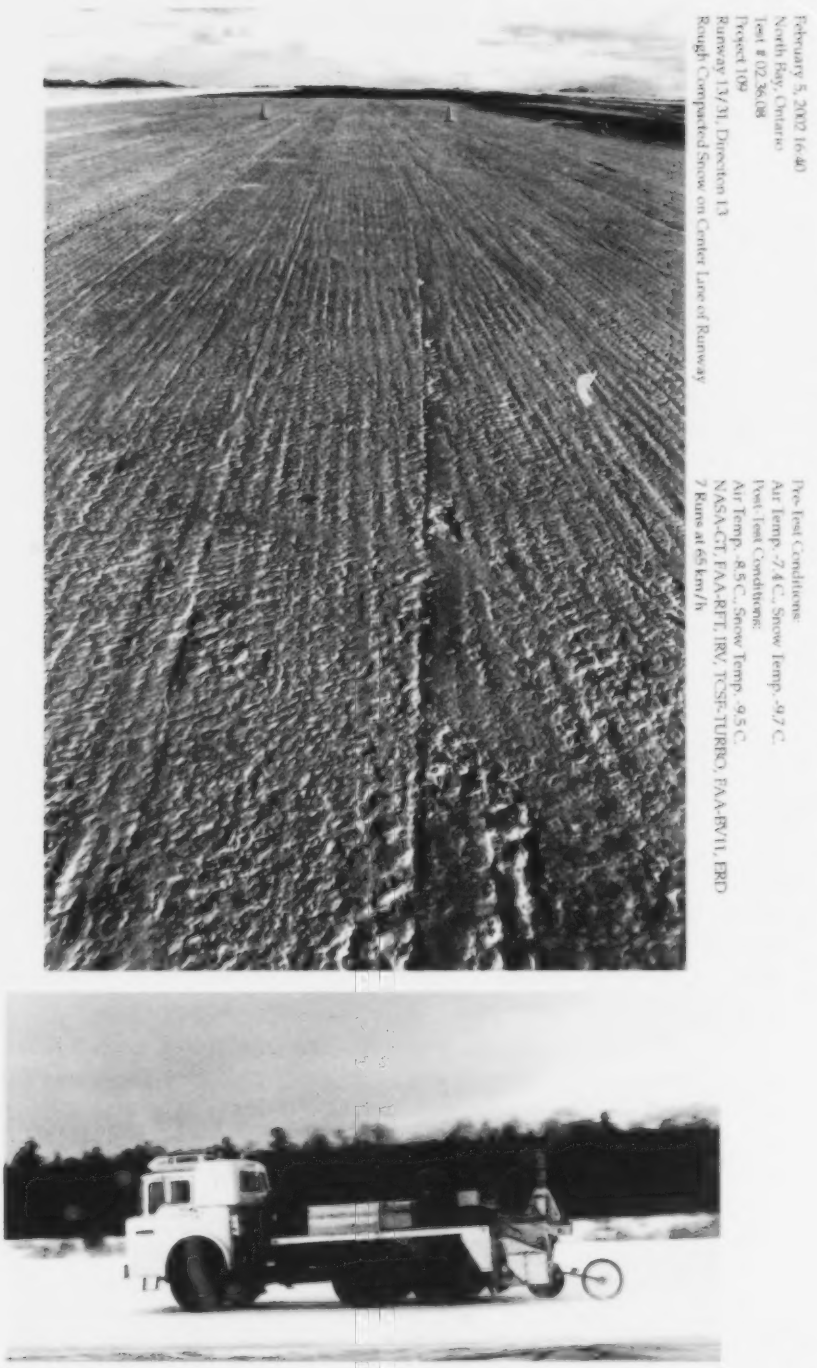
February 5, 2002 16:40
North Bay, Ontario
Test # 02.36.08
Project 109
Runway 13/31, Direction 13
Rough Compacted Snow on Center Line of Runway
Pre-Test Conditions:
Air Temp. -7.4 C, Snow Temp. -9.7 C
Post-Test Conditions:
Air Temp. -8.5 C, Snow Temp. -9.5 C
NASA-GT, FAA-RFT, IRV, TCSF-TURBO, FAA-BV11, ERD
7 Runs at 65 km/h

Figure 14. Compacted snow strip on the centre-line of runway 13-31 (a) and the NASA-ITTV on the compacted snow (b) during the afternoon of 05 February 2002

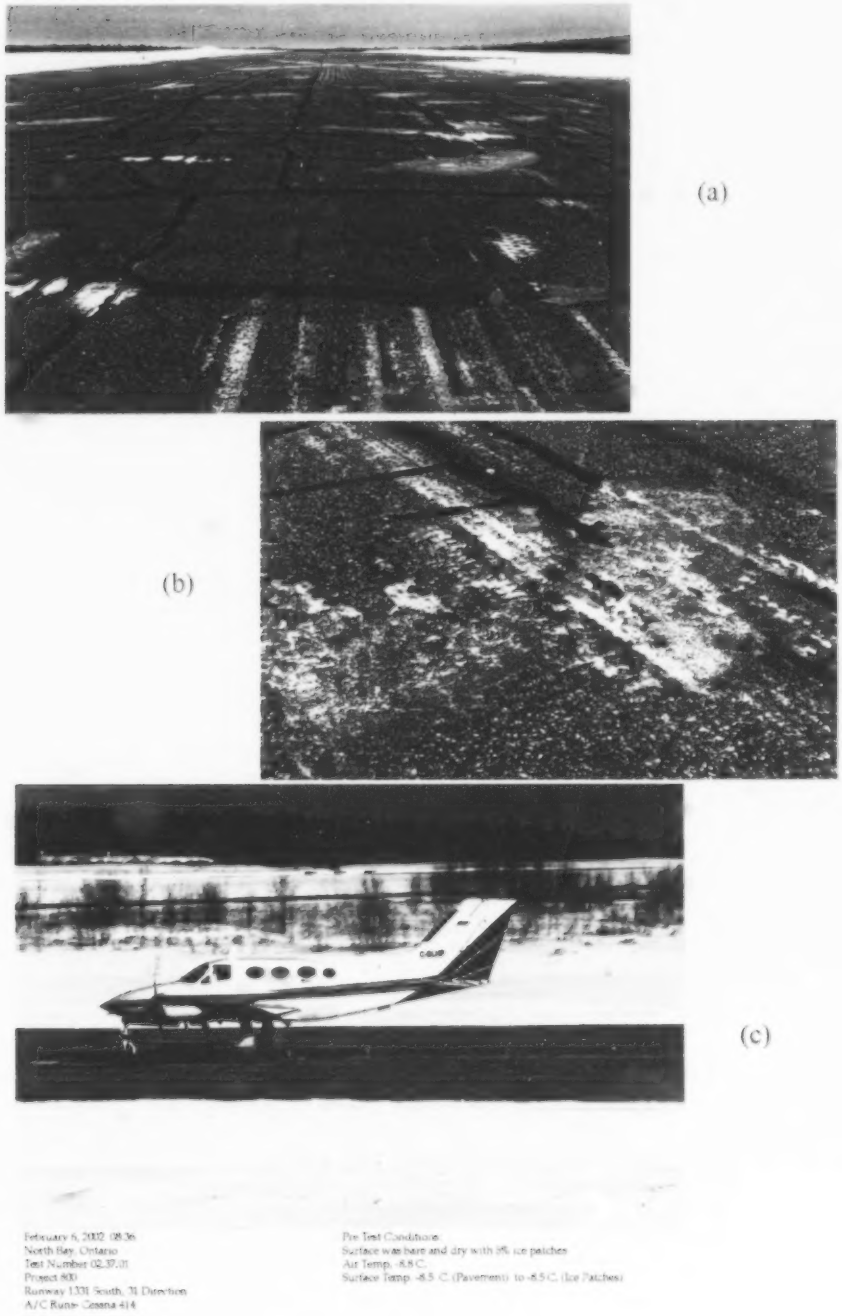
Figure 15. Runway 13-31 conditions during the morning aircraft tests on 06 February 2002: general view looking towards south (a), snow/ice patches (b) and Cessna 414 during a test (c)

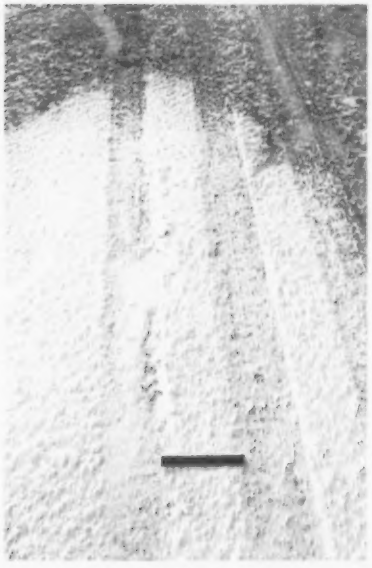
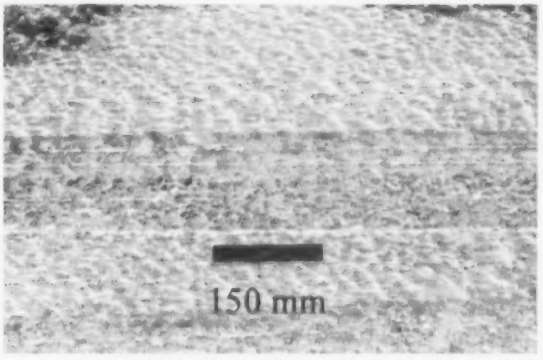
Figure 17. Cessna 414 testing (No. 02.38.05, Project 801) on runway 13-31 south in the evening of 07 February 2002 from about 16:30 to 17:30 (a) and aircraft tire marks in a snow patch (b, c). The marker on the snow is 150 mm in length.

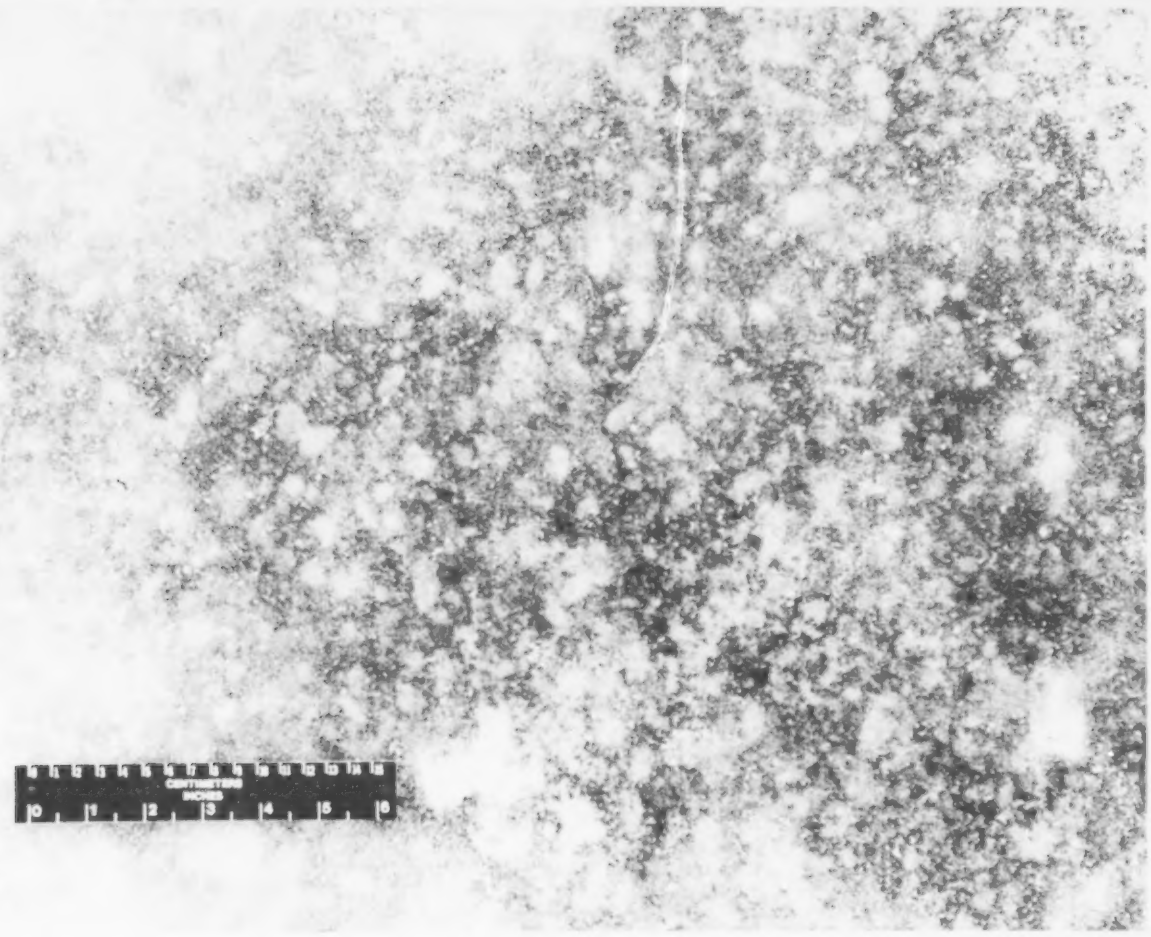
Jan. 29,2001, 09:20
North Bay, Ontario
Test #02.29.01
Project 410
Runway 1331, West Side, 31 Direction
IRV/ERD Comparison, Variable Slip on ICE

Man-made Ice Test Surface
Conditions Before Testing
Air Temp. -16.5
Surface Temp. -11.0 to 11.2
IRV, ERD, TCFST-TURBO

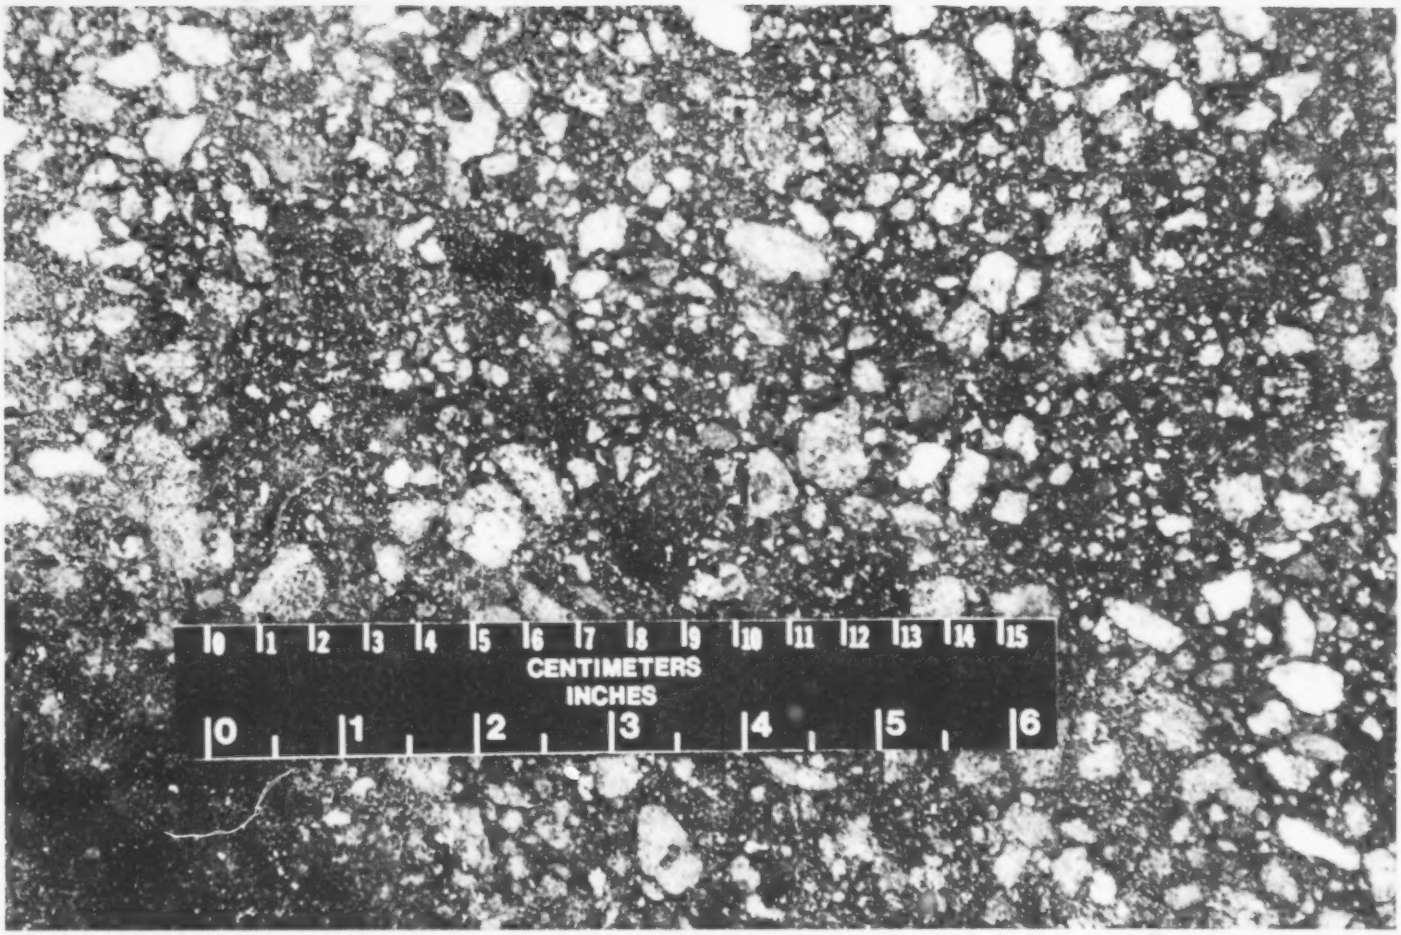
Jan. 29,2001, 09:20
North Bay, Ontario
Test #02.29.01
Project 410
Runway 1331, West Side, 31 Direction
IRV/ERD Comparison, Variable Slip on ICE

Man-made Ice Test Surface
Conditions Before Testing
Air Temp. -16.5
Surface Temp. -11.0 to 11.2
IRV, ERD, TCFST-TURBO
Detail of Thin, Clear Ice

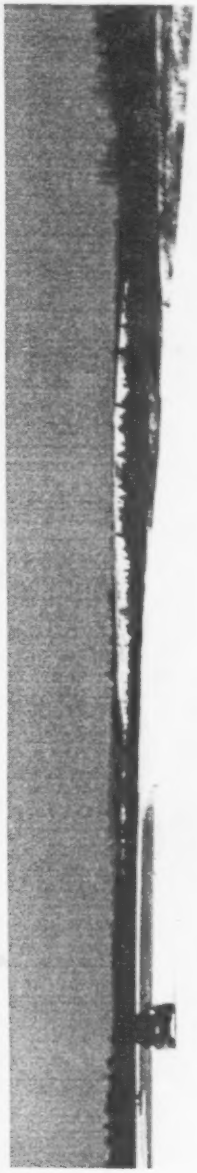
January 30, 2002 16:55
North Bay, Ontario
Test Number 02.30.03, Project 416
RWY 1331 North, 13 Direction, East Side
IRV/ERD Comparison
Variable Slip on ICE

After All Tests:
Air Temp. -12.7 C.
Surface Temp. -7.4 C. (Thin Ice) to 8.4 C. (Thick, Bubbly Ice)
Man-made Ice, 5mm-20mm thick, wavy with small bumps.
Ice developed many cracks, running both parallel and perpendicular to the length of the strip.

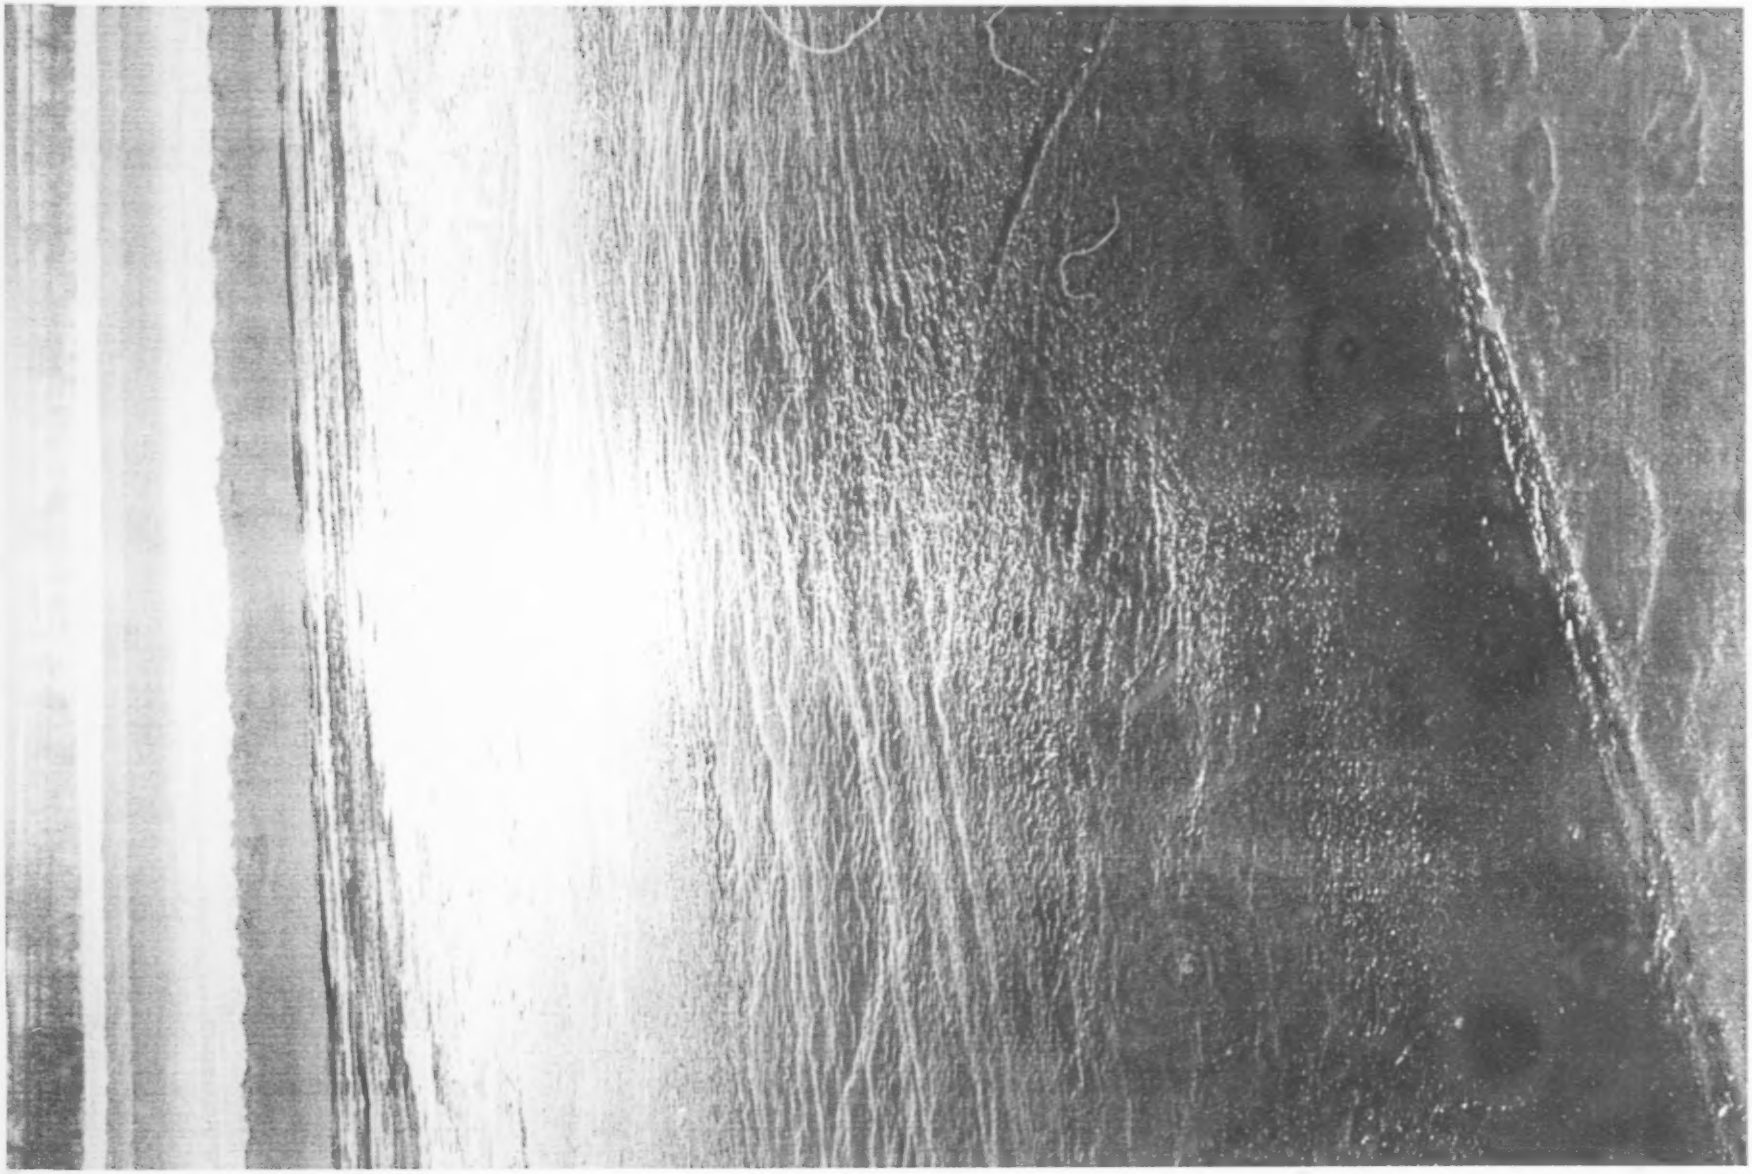
January 30, 2002 16:55
North Bay, Ontario
Test Number 02.30.04, Project 417
RWY 1331 North, 13 Direction, East Side
IRV / ERD Comparison
Variable Slip on COMPACTED SNOW

IRV-PIARC Smooth, High Load, High Pressure
After All Tests:
Air Temp. -12.7 C., Surface Temp. -12.6 C. .
10mm Loose, Aged Snow on Compacted Snow;
Total Depth 30 mm. North end, 50mm South End.
Test strip was in bad, damaged condition; rutted and bumpy.

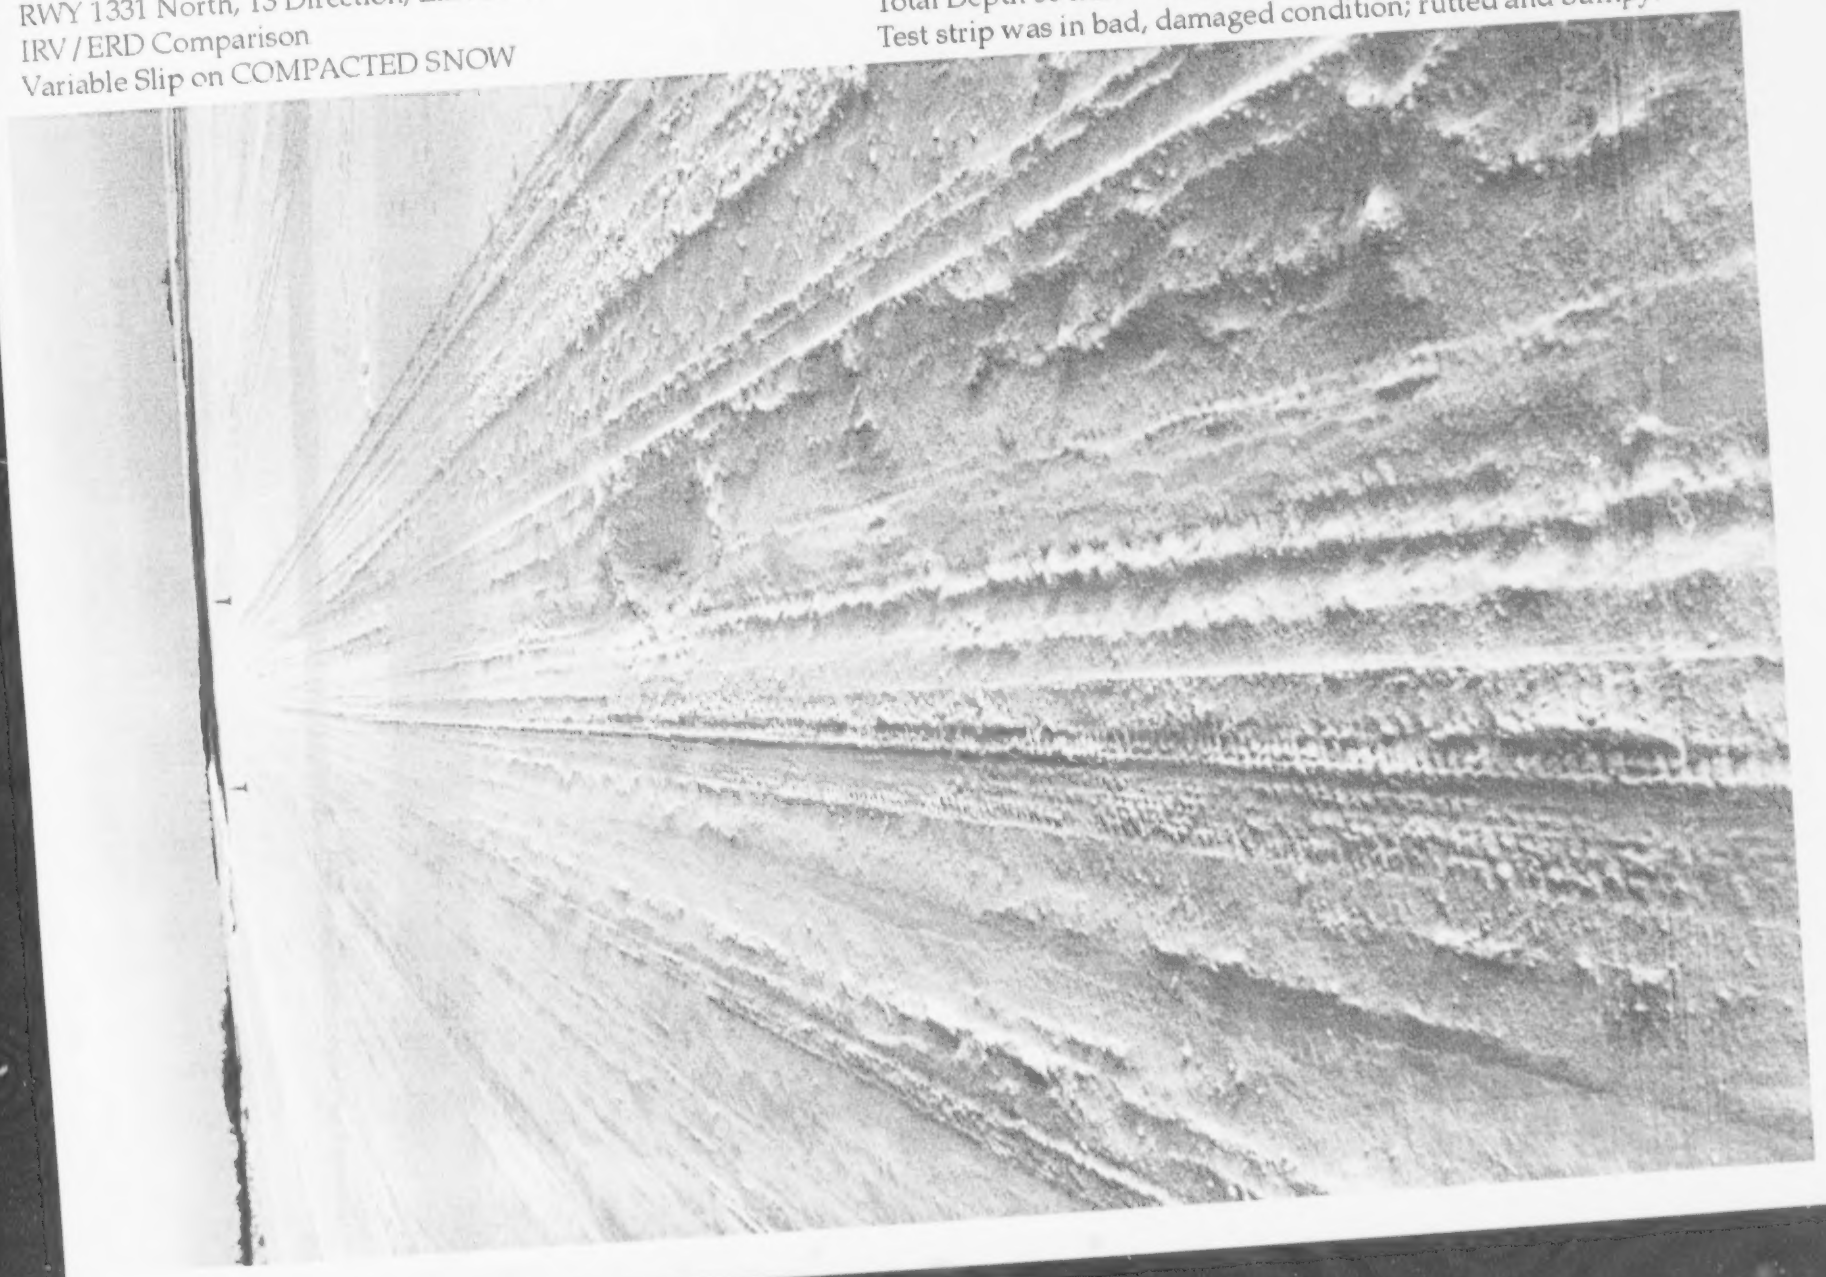
February 2, 2002 14:35, North Bay, Ontario
Test Number 02.33.06, Project 437
Runway 1331, West of Center Line
IRV/ERD Comparison
IRV-A/C Tire, High Load, High Pressure
Variable Slip on COMPACTED SNOW

Pre Test Conditions: Air Temp. -12.2 C.
Surface Temp. -10.1 C. (Compacted snow) to -10.2 C. (Icy Crust)
Very uniform and highly compacted, with a texture created by the tires of the heavy snow removal equipment. Some ruts were created by ERD tires. Repeated test runs had caused an icy crust to form on the raised parts of the texture. (Visible in photo)

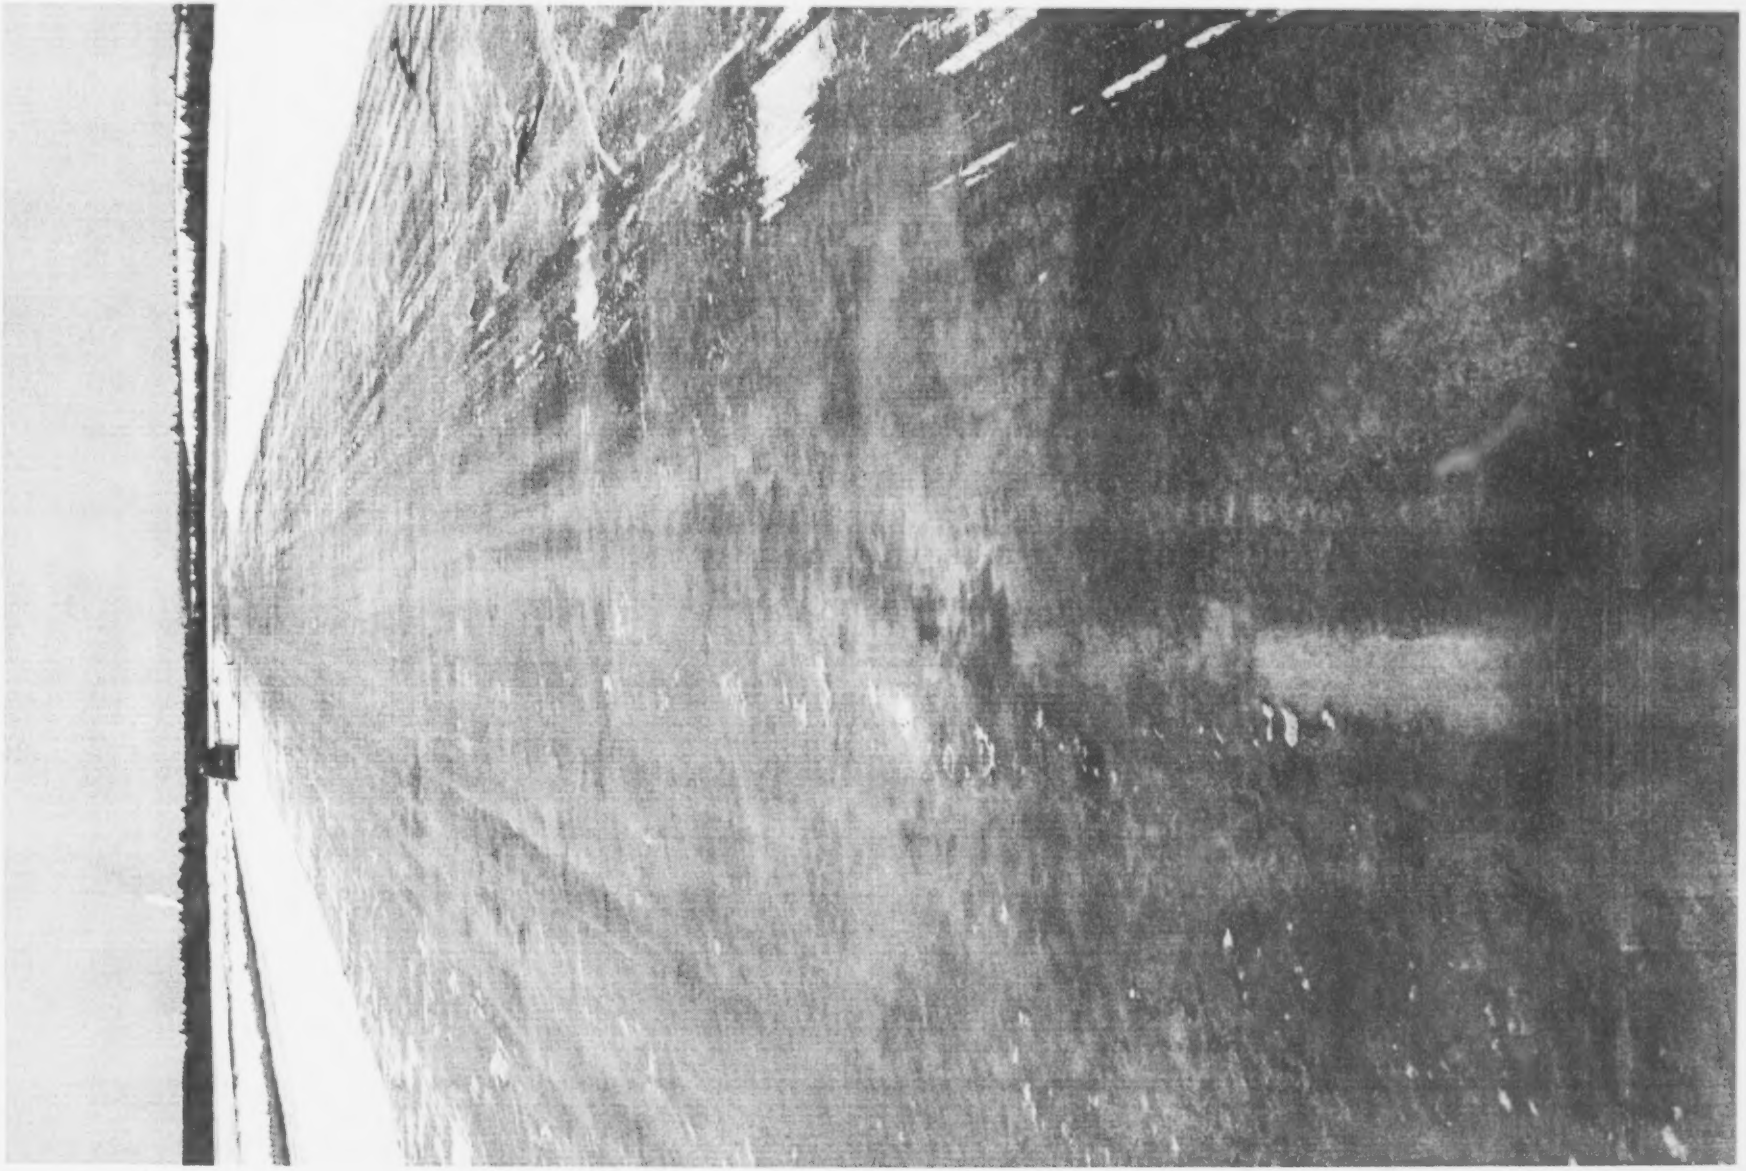
February 2, 2002 14:35, North Bay, Ontario
Test Number 02.33.05, Project 436
Runway 1331, West of Center Line
IRV/ERD Comparison, Variable Slip on ICE
IRV-A/C Tire, High Load, High Pressure
Variable Slip on ICE

Conditions After 3 Sets of Tests: Air Temp. -12.2 C.
Surface Temp. -1.1 C. (Clear Ice) to -3.8 C. (Thicker, Bubbly Ice)
The ice test strip was now exhibiting severe cracking in some areas, and long strips of herring bone cracking were visible (shown). There were some areas in which the ice was crushed and water was visible.
